## **Industrial Water Division**

## **ProMoss™ Trial at Corning Inc.**

Corning, NY

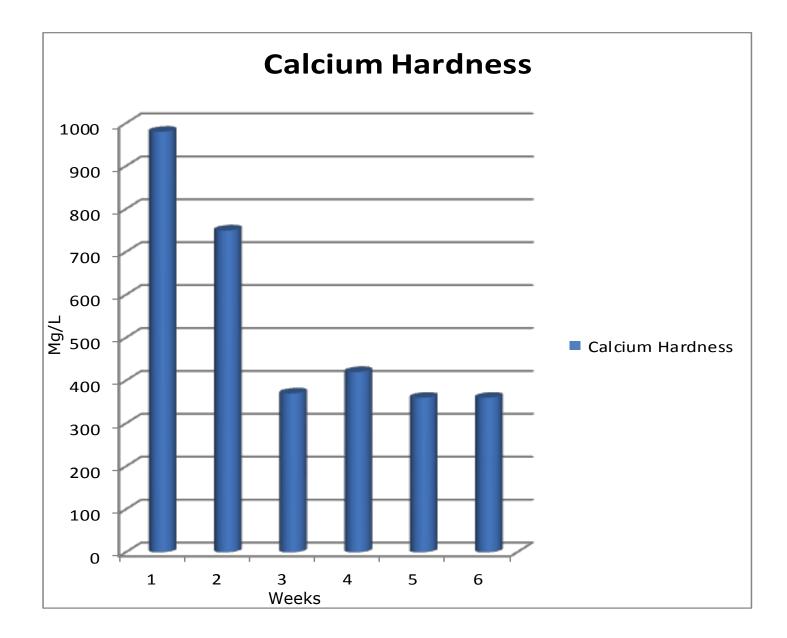
#### Water Chemistry Data from ProMoss<sup>™</sup> Tower (Kiln Tower #2)

6/4/2015	6/26/2015	7/17/2015	8/6/2015	9/5/2015
🔶 Ca Hrdn	750	370	420	360	360
Total Hrdn	1129	769.5	872.1	1060.2	1060.2
Cond	2100	1800	1900	2200	2200
Cl		300	300	330	305
<b>——</b> рН	7.8	8.5	8.4	8.7	8.7
	140	460	420	340	480
	0	0	0	0	0
🛨 Fe	0.4	0	0.4	0	0
Si	40	40	40	40	40
	1	0	0	0	0
