### Summer pool opening at the Knighton House – 4<sup>th</sup> Year Update

# ProMoss™ Cleans Up a 1300 Ton Hospital Cooling Tower

By: Steve Chewning – Vice President of Field Operations - Southeastern Laboratories, Inc.

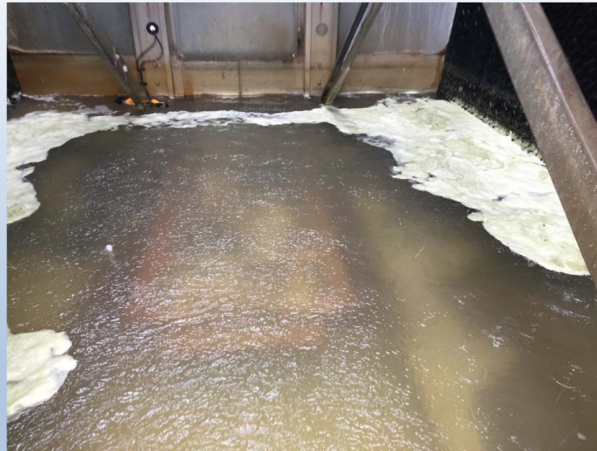
Start of Trial – on Chemical Treatment

The system had higher than expected bacteria levels with correspondingly high ATP values. Water clarity was poor and there were significant iron and copper levels present indicative of active corrosion occurring in the system.

Total Bacteria Count  
 $10^7$  CFU/ml

ATP – 2610 RLU's  
Turbidity – 28 NTU's  
Iron – 1.69 ppm  
Copper – 0.42

A major medical facility in the Southeast US recently implemented a ProMoss™ trial on their 1,300-ton HVAC cooling tower system. The system had been operating under a conventional chemical treatment program utilizing an inhibitor product and two micro biocides. Conditions at the start of the trial are summarized below.

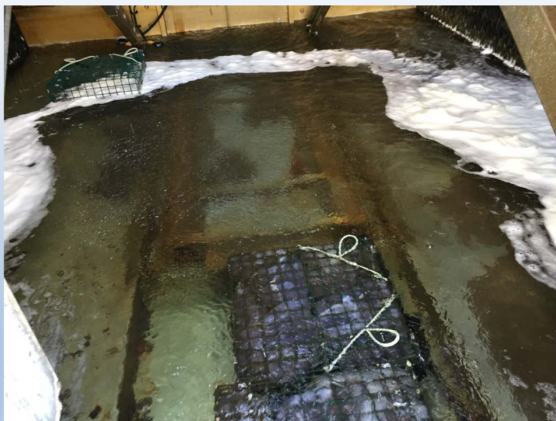
Two Week's Into ProMoss Trial

Total Bacteria Count  
 $10^2$  CFU/ml

ATP – 126 RLU's  
Turbidity – 2 NTU's  
Iron – 0.02 ppm  
Copper – 0.29

- Total bacteria counts dropped from  $10^7$  to  $10^2$  CFU/ml
- ATP dropped from 2,610 to 126 RLU's reflective of the bacteria count drop
- Water clarity (turbidity) improved significantly dropping from 28 to 2 NTU's
- Iron levels were reduced from 1.69 ppm to 0.02 ppm
- Copper levels were reduced from 0.42 to 0.29 ppm

ProMoss™ was introduced to the system using cages dropped into the cooling tower sump. All chemical feed was discontinued. After two weeks, the following conditions were observed.

Throughout the 3-month trial total bacteria counts remained in the  $10^2$  to  $10^3$  range with ATP values averaging 182 RLU's. This was impressive considering the trial was conducted during the high load Summer season, which places the highest demand on microbiological control. Iron and copper levels averaged 0.09 ppm and 0.21 ppm respectively during the trial.
