Moss Briefs:

Before and After ProMoss™

BAC Cross Flow Cooling Tower located in downtown Clearwater. System was without treatment for 2-3 years. System is made up with soft water. The last known treatment service was zero bleed. System must have had interruptions in softener service as tower fill is loaded with calcium carbonate scale.

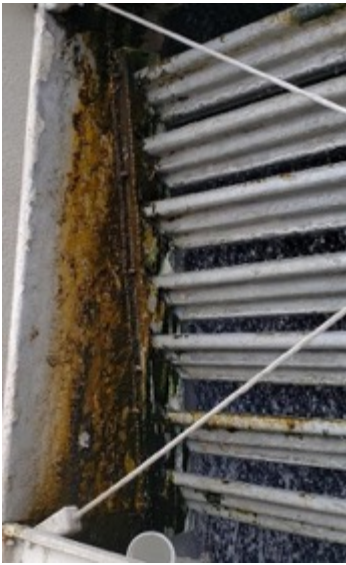
Before ProMoss™

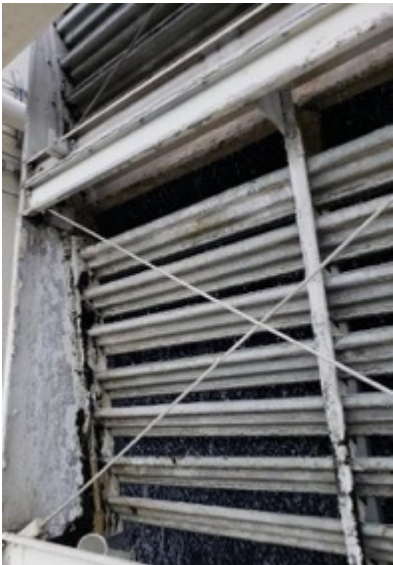
After 1 month of ProMoss™

- Observed calcium carbonate scale begin to detach from tower fill within 2 weeks after ProMoss™ addition.
- Observed removal organic contamination
- Continued to vacuum out scale debris from tower basin every 2 weeks

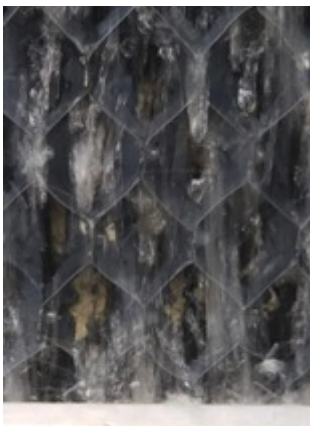
Before ProMoss™

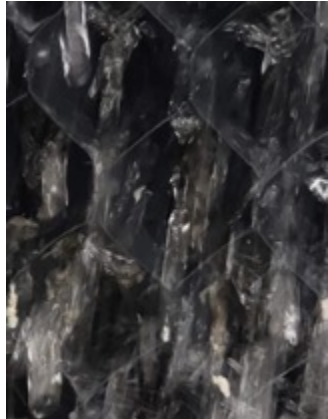
After 1 month of ProMoss™

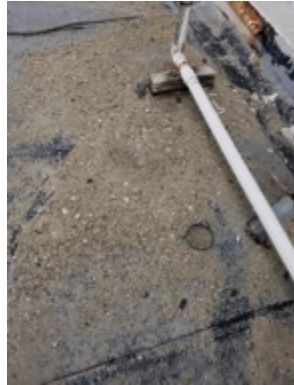
Picture was taken during evaluation when system was off line

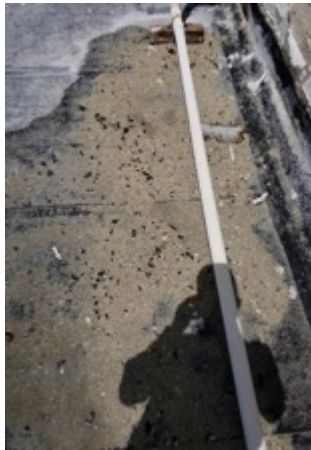
After 4 weeks

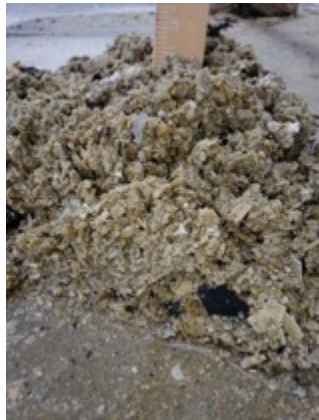
After 6 weeks

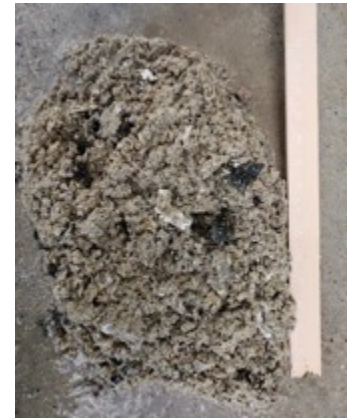
2 months after starting ProMoss™
