# Industrial Water

Cooling Tower

Case studies and analysis

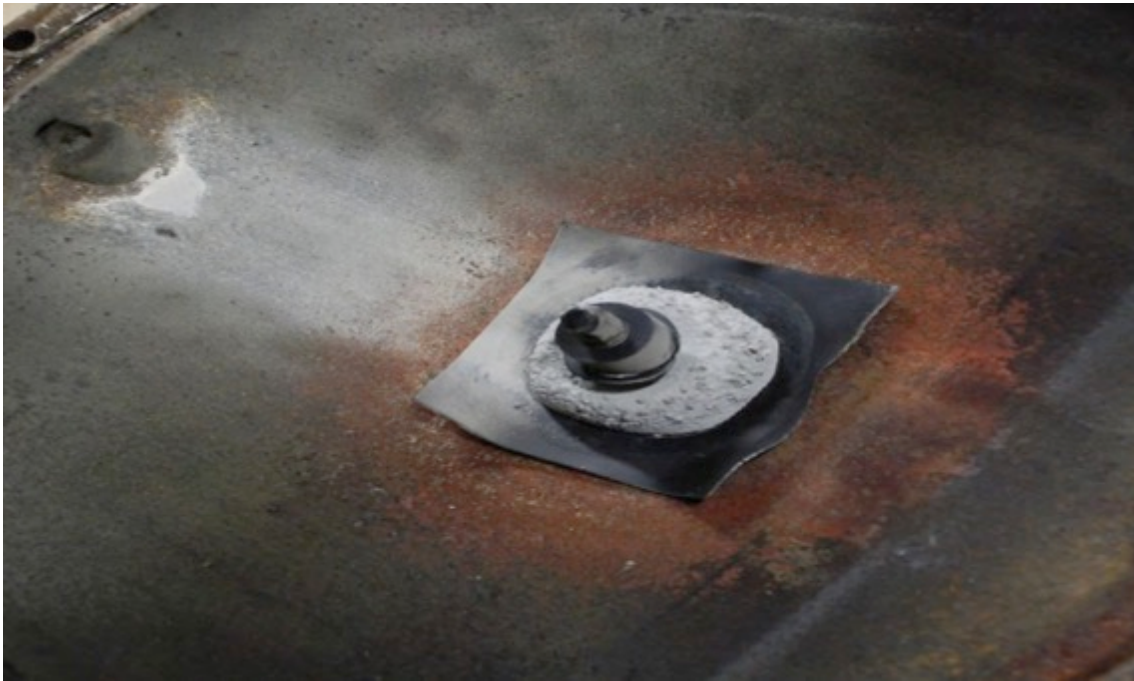
*Chiller lid from phase one test facility after two cooling seasons on ProMoss™.*

All treatments stayed the same except the blow-down setting was increased from 1800 to 3600 to see if the increased TDS would result in scale formation, corrosion or less efficient chemical control. No scaling occurred on the tower, there was a decrease in chemical consumption, and it took 0.5 hours to clean the tower the next year. The heat exchanger was scheduled for maintenance during the winter. There was no scaling or corrosion on the exchanger tubes and no cleaning was required.

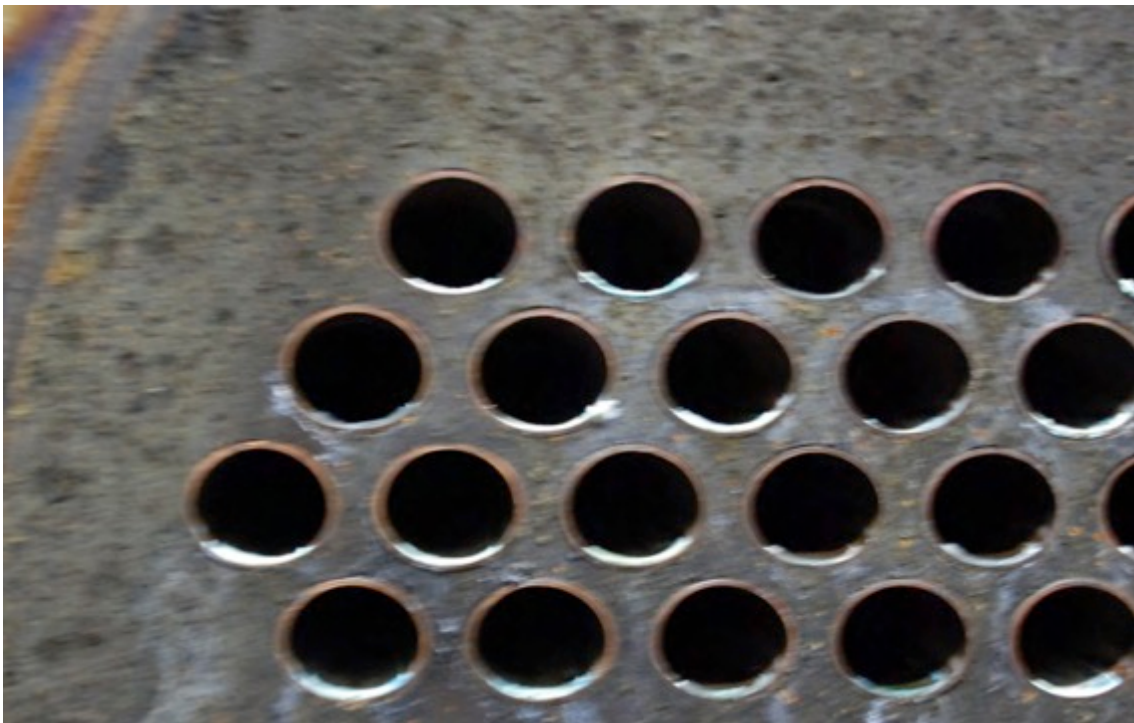
*Chiller tubes from phase one test facility after two cooling seasons on ProMoss™*

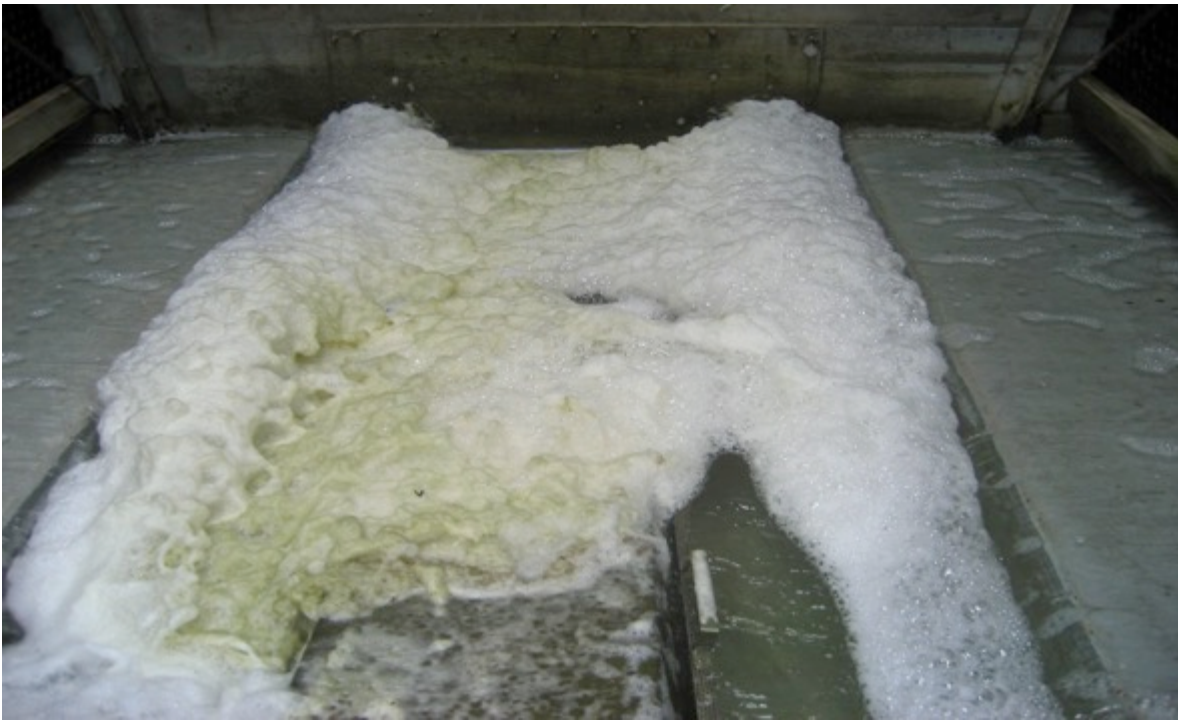
*Water, foam, and organic contamination before starting on ProMoss™*

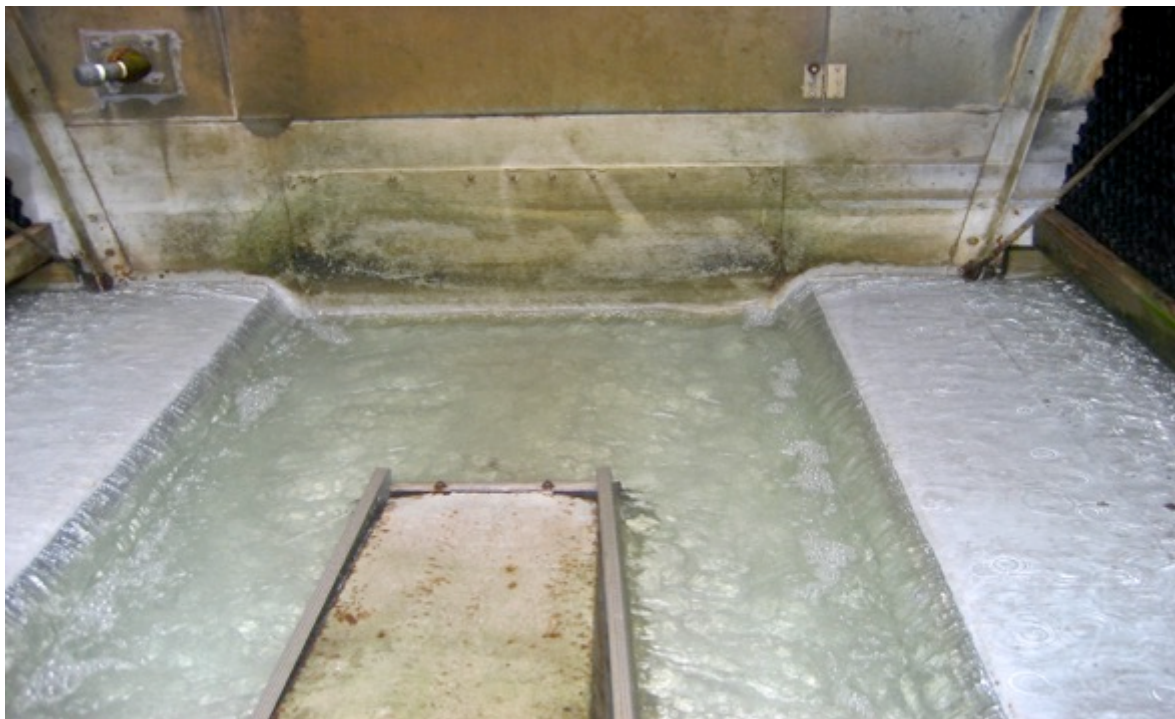
*Water after two years treatment with ProMoss™ Note clarity, absence of foam and organic contamination*

ProMoss™ treatment was highly effective in removing foaming, organic contamination, scaling, and improving water clarity. It treated the water loop and resulted in no scaling or corrosion in the chiller. As a result the facility realized water savings, reduction in number and amount of chemicals needed, and an overall savings of over 50%.

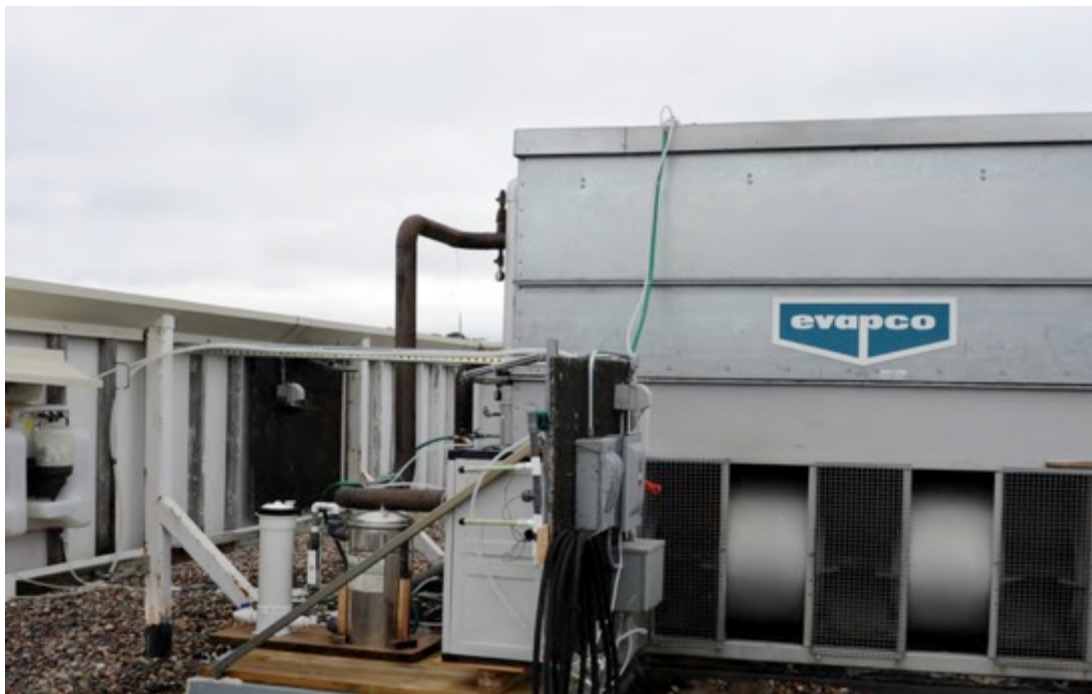
Sphagnum moss delivery system used on three different facilities. Stainless steel tank contains the Sphagnum moss, white PVC cylinder is a filter and two LPR probes are in line.

We contracted a local water treatment company, Jay Tech, to independently test three different facilities. They created a flow through system with a filter and separate contact chamber similar to the system used to deliver the Sphagnum moss to a residential pool (Figure 2). LPR probes for galvanized and soft steel were installed inline. Sphagnum moss treatment was started on July 14, biocide delivery remained unchanged, and corrosion, dispersant and scale inhibitors were stopped.

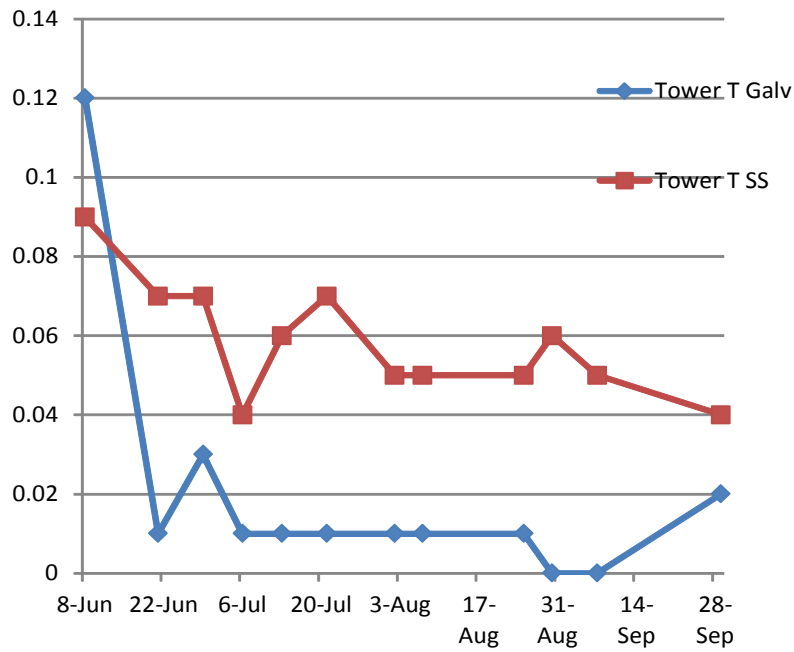
Corrosion values for Phase Two tower 1. Galvanized steel is in blue and soft steel in red. Dispersant and corrosion inhibitors removed on July 14.

We concluded that the measured corrosion was the same as or decreased when the corrosion inhibitor was discontinued on all three towers. The flows through systems had frequent fouling of the filters, were expensive, and were removed. We decided to return to the contact delivery cages in the basin of the towers for the next studies.

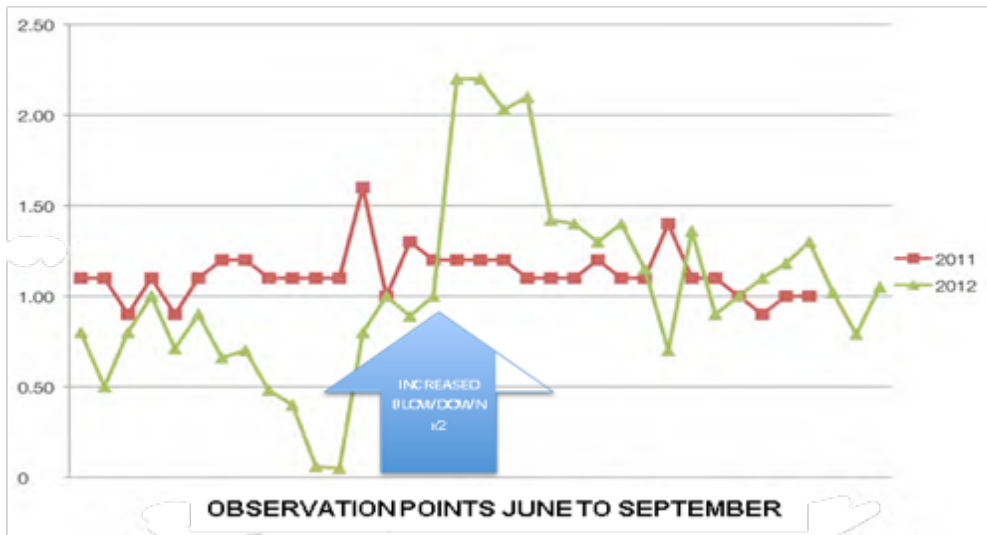
Corrosion inhibitor concentration comparison from Phase Three. Blue arrow is when blow-down settings were increased from 1800 to 3600

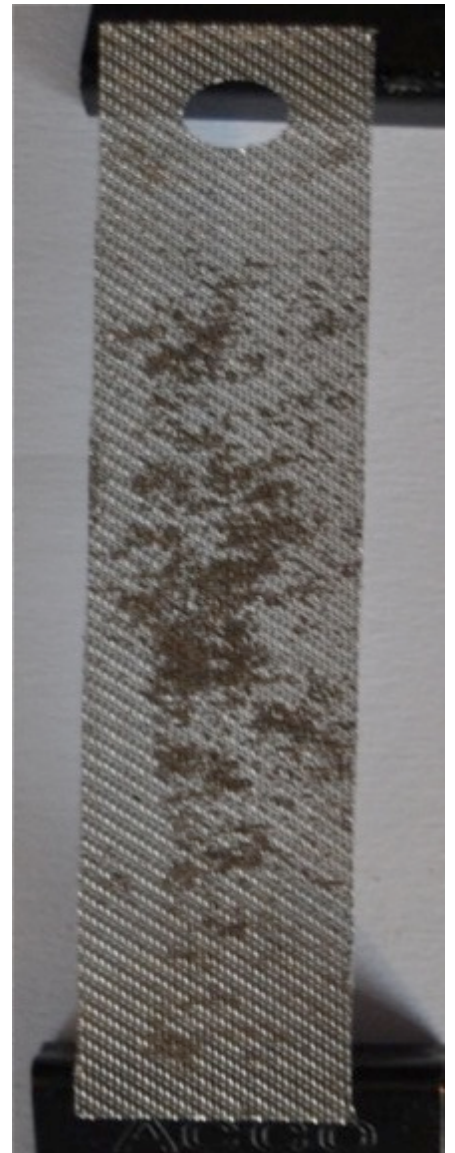
## ORGANIC CONTAMINATION ACCUMULATION

Control Cooling Tower without ProMoss™

Water was treated with two biocides, a dispersant  
and corrosion inhibitor.

The same two towers as in year one were treated with Sphagnum moss and a third ,650 ton, tower was used as a control. We measured corrosion for copper with both coupons and probes, and measured organic contamination formation using special mesh coupons. All three towers were treated with two biocides, corrosion inhibitor and dispersant.

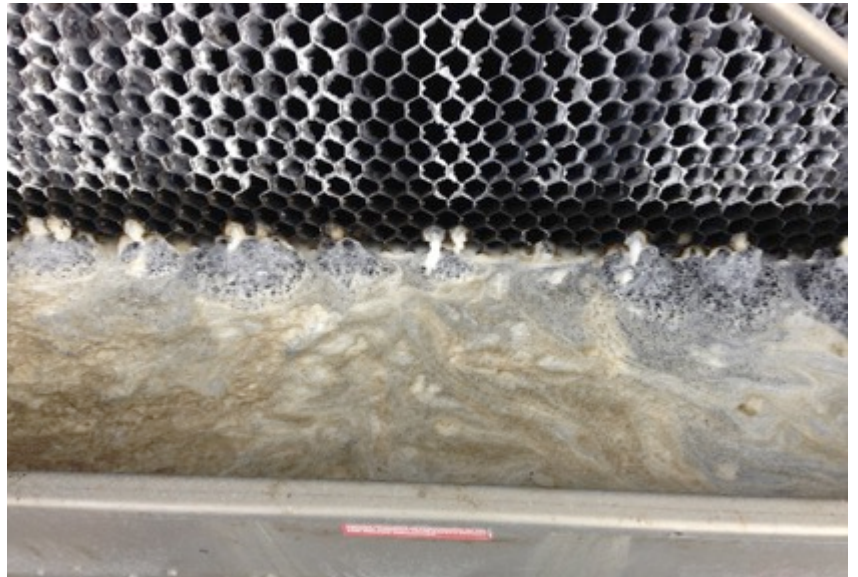
*Foaming in return water (note foam coming from the media)*
